DELAWARE RIVER BASIN,
TROUT BROOK, SUSSEX COUNTY,
NEW JERSEY.

LAKE PLYMOUTH DAM

(NJ 00818)

PHASE I INSPECTION REPORT.
NATIONAL DAM SAFETY PROGRAM

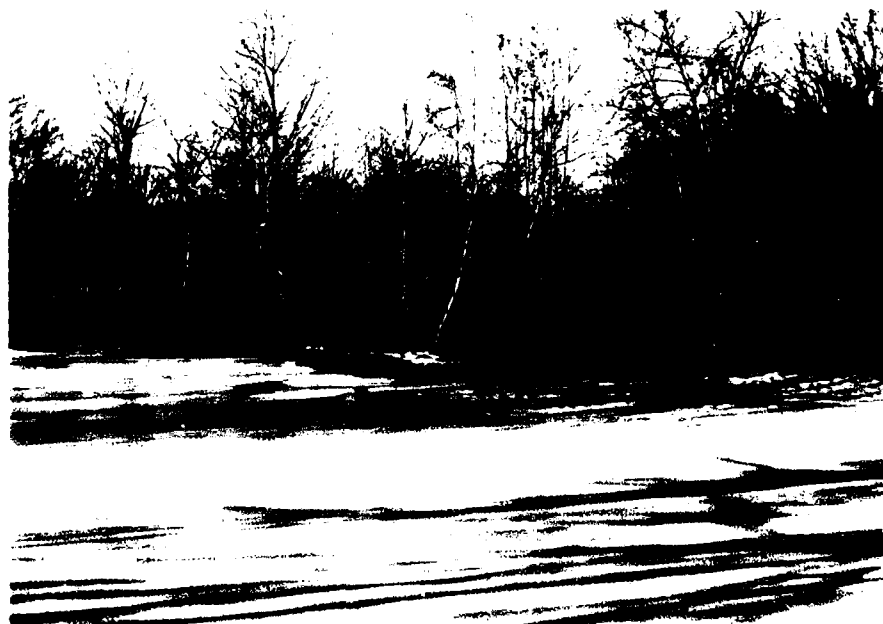
The concrete in the spillway section appeared to be haphazardly placed and did not form satisfactory stabilization. The sideslopes of the trapezoidal section were stabilized on the left by grouted riprap and contained no significant stabilization on the right. The downstream slope of the spillway was formed by riprap. There were small trees growing in the spillway and on its downstream side. The trees ranged in size from 1 inch to 3 inches. The overall stabilization of the soil in the spillway appeared to be inadequate.

PHOTO 2
UPSTREAM VIEW OF SPILLWAY

(2) The spillway should be thoroughly renovated to provide adequate slope protection for the embankment.

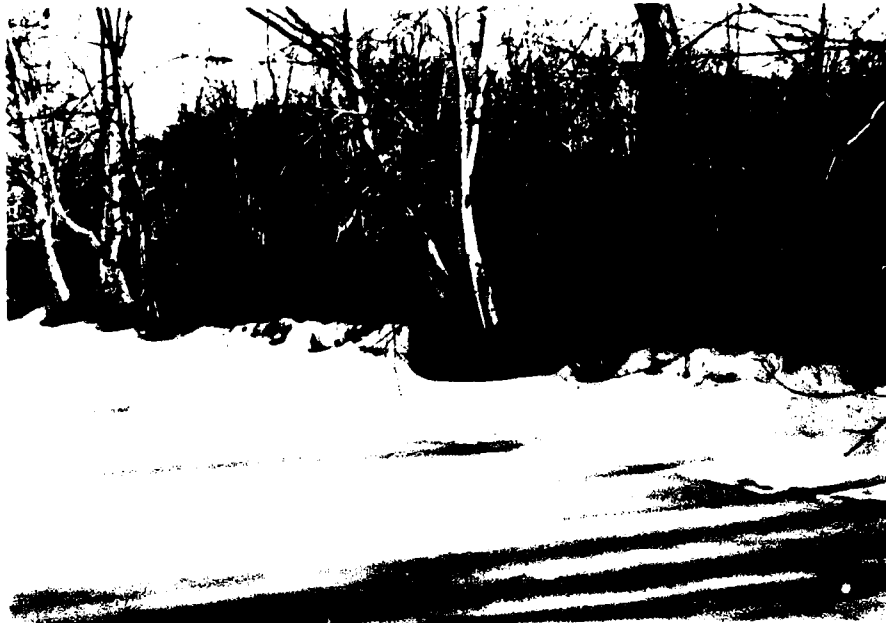
PHOTO 5
UPSTREAM FACE OF DAM

(1) The upstream face and crest of the dam should be properly protected against erosion.

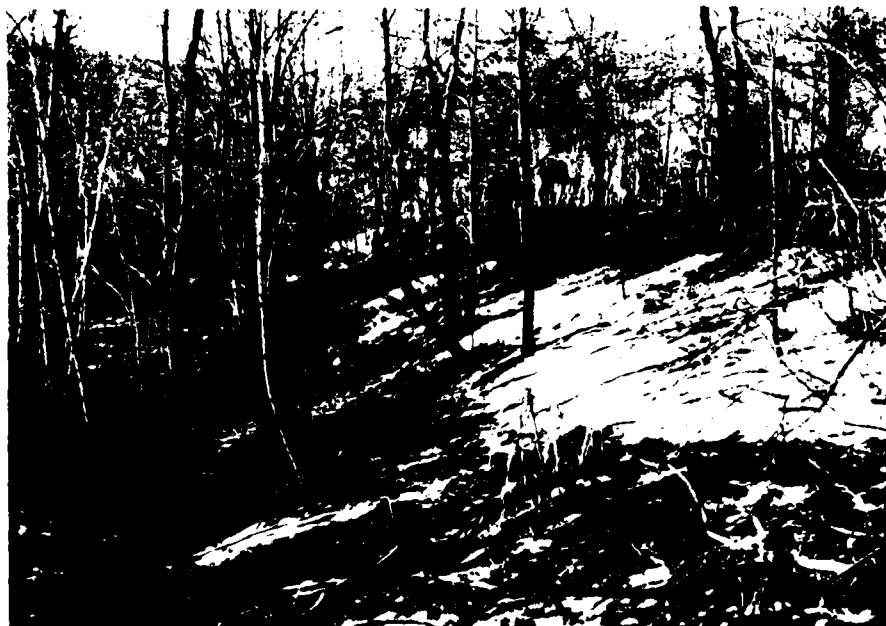
PHOTO 6
DOWNSTREAM FACE OF DAM
